Field Welding Repair of Heavy Equipment

Phil Akahori

California Polytechnic State University
San Luis Obispo, California

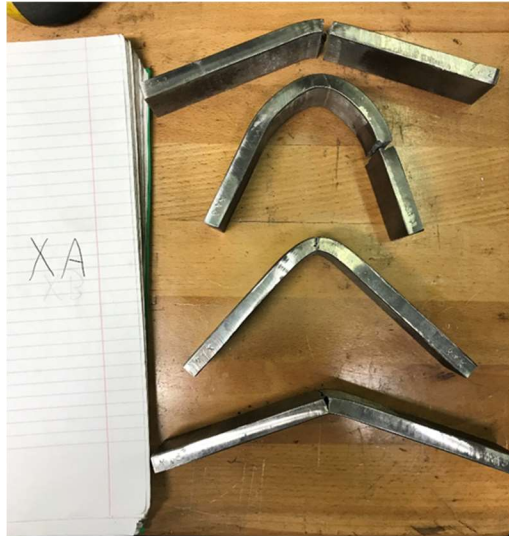
Figure 1. Profile view of procedure "XA" guided bend tests

Guided bend tests were done with a roller-equipped bend test jig using 2.5” rollers to match the >90 ksi steels and filler metal per AWS D1.1. XA failed with brittle fracture directly adjacent to the weld

on the 4140 side in 3 of the samples. These three samples also show very little deformation in the base metals. All ductility seems to have taken place within the weld area and the sample simply hinged in the weld prior to fracture. One root bend shows some deformation in the base metal but then fractured ~2" away from the weld in the 4140 before making fully through the bender as can be seen in Figure 1. The weld area of these samples would have passed as discontinuities are $<.375"$.

The guided bend test is perhaps not the best way to verify this type of welding with dissimilar metals. Ultimately, we want a hard tooth welded to a bucket with a ductile weld able to take an impact. A hard material in a guided bend test that requires deformation of the metal might not be ideal in evaluating this special application's weld even if the structural welding code calls out such testing. However, there are some observations that can be made. The first being the 4140 side seems to be the side of concern with all the fractures taking place adjacent to the weld or farther along in the sample. Secondly, the samples that did the worse were all face bends in all the procedures. The root bends performed far better. This is counter intuitive of typical guided bend test results. The root bends typically display concern. In this instance, this could be due to the amount of heat the root area of the plates experience. In all the procedures more heat was concentrated at the bottom and then moved up. This could suggest that a "tempering bead" on the surface near the cover passes is all that would be needed to introduce ductility into the base metal. The "butter" of XC and XD might have not had enough effect around the face of the base metals. Thirdly, many of the root bend samples fracture 2" away from the weld. This could possibly be explained simply due to geometry as the sample goes through the bender. Or some grain growth is happening in all the procedures in that region. The temperature gradient through the sample test plates is producing temperatures in that region that are just right to make detrimental metallurgical changes in the base metal such as the Widmanstatten structure mentioned above. The performance in XC and XD might also be explained due to the large size of the weld metal in these samples. The ductile filler metal was able to deform over a larger area compared to that of the small welds of XA and XB.

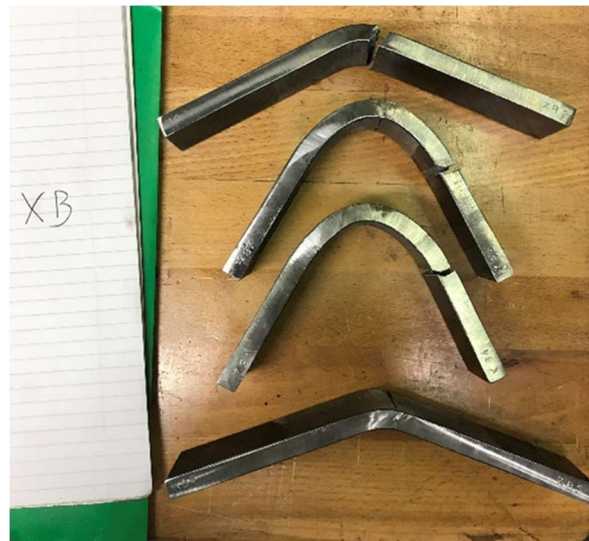
Figure 2. Profile view of procedure “XB” guided bend tests

"XB" showed similar failures to that seen in "XA." The two face bend specimens have a fracture adjacent to the weld in the 4140 side with little to no deformation in the base metals. The root bends show more deformation in the base metals but still fractured in the 4140 side ~2" from the weld before making it fully through the bender as can be seen in Figure 2. The weld areas in these two root bends would have passed as discontinuities are $<.375"$.

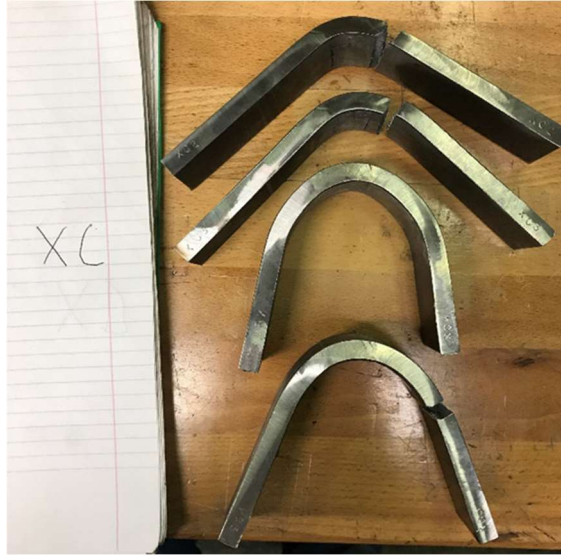
Figure 3. Profile view of procedure “XC” guided bend tests

“XC” seems to have performed the best. One root bend sample passed, third sample down in Figure 3. There was no fracture and discontinuities are $<3/8$ ". Both face bends had a fracture adjacent the weld in the 4140 side. The other root bend fractured ~ 2 " away from the weld in the 4140 side.

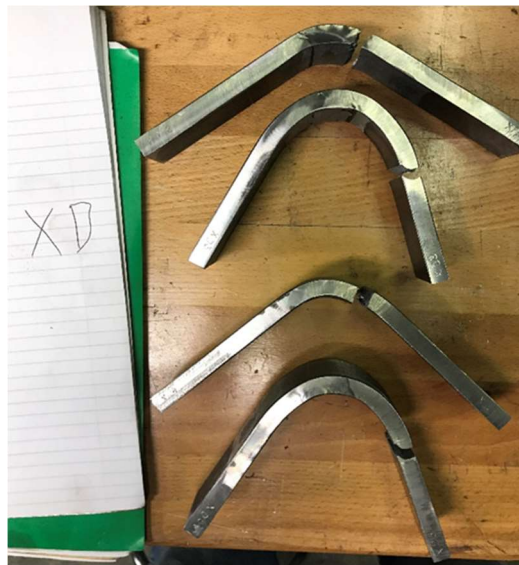
Figure 4. Profile view of procedure “XD” guided bend tests

In the “XD” samples, both face bends fractured adjacent to the weld on the 4140 side as noted in Figure 4. The root bends fractured ~ 2 " away from the weld in the 4140 base metal and the weld area of these samples showed total discontinuities $<.375$ ".
